# TRADITION CONTINUES

NEW HOME FOR THE PARADE COMPANY AT THE BRODHEAD ARMORY  
APPLICATION TO THE HISTORIC DISTRICT COMMISSION

**ROSSETTI**

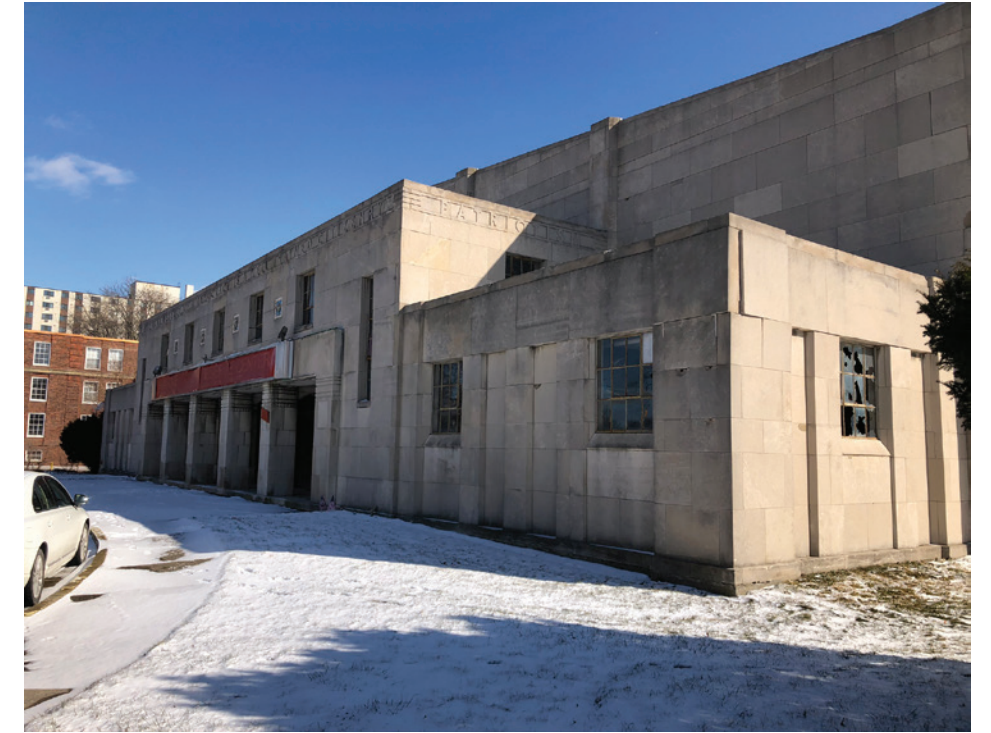
While the exterior masonry of the Jefferson Avenue Block, or North Block, is generally intact, over the years it has sustained environmental damage that has neither been remediated through repair nor proactively averted through periodic facility maintenance.

As a result, deterioration of the exterior is visible in a number of locations. Many of the windows have also been damaged or compromised.

The limestone panels will require cleaning. A number of the exterior architectural details, such as Pewabic pottery tile and memorial elements, have either been damaged or removed. These will require replacement or repair.

In addition to these conditions, and exacerbating an already unfortunate rate of interior degradation, the roof of the North Block sustained major damage years ago. This has permitted unabated water ingress and direct exposure of the interior to the elements.

The repair and rehabilitation of the entire building envelope for the North Block will require extensive investment. We believe, however, that the Armory's heritage and its eminent position in Detroit's historical narrative are uniquely complementary to the legacy of the Parade Company. As such, the Brodhead Armory will be an exceptionally fitting 'front door' for the Home of America's Thanksgiving Parade.

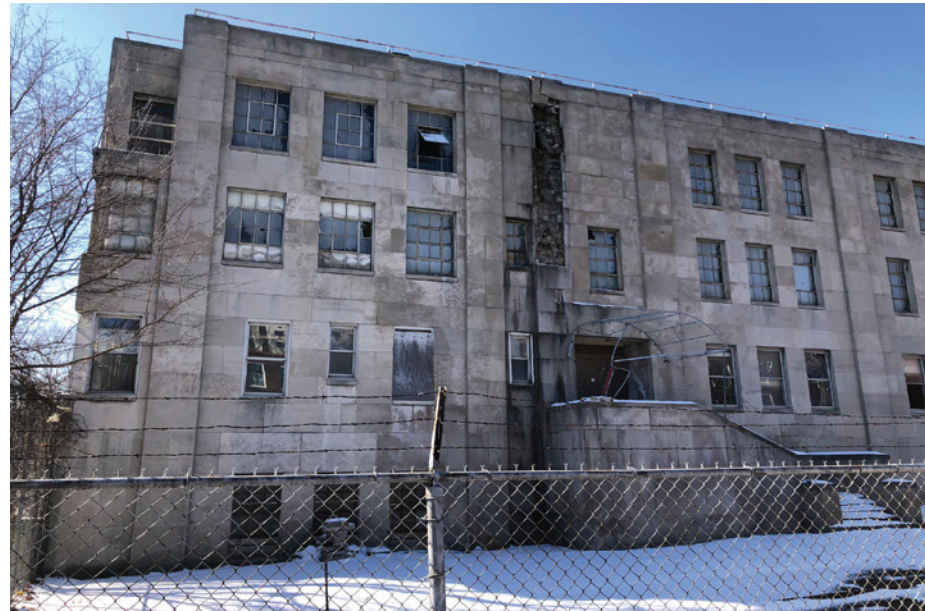
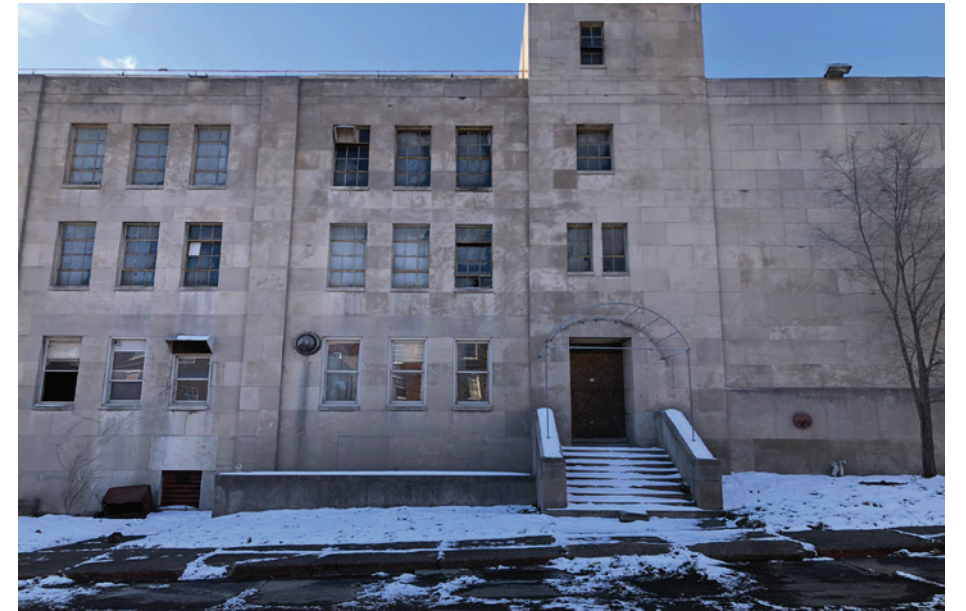
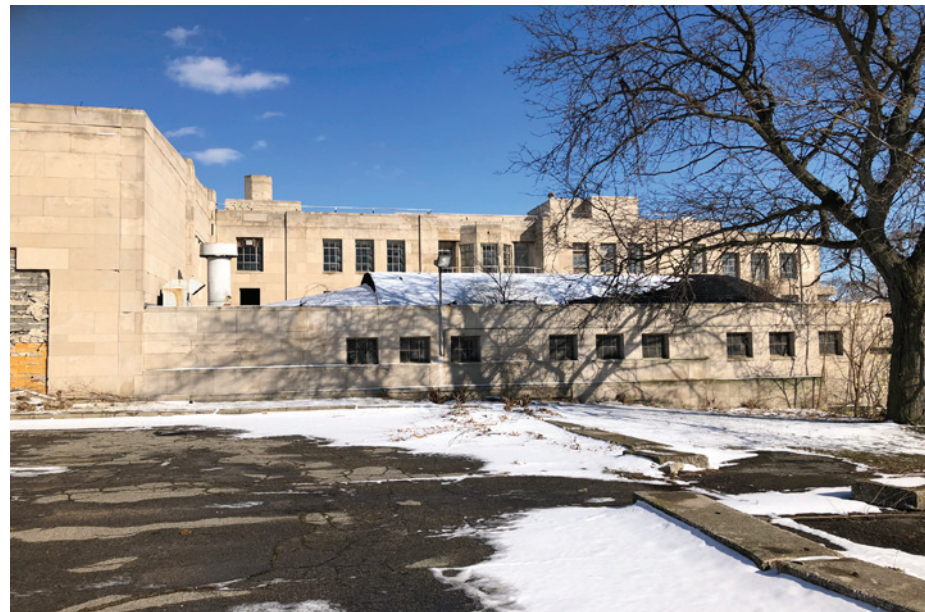
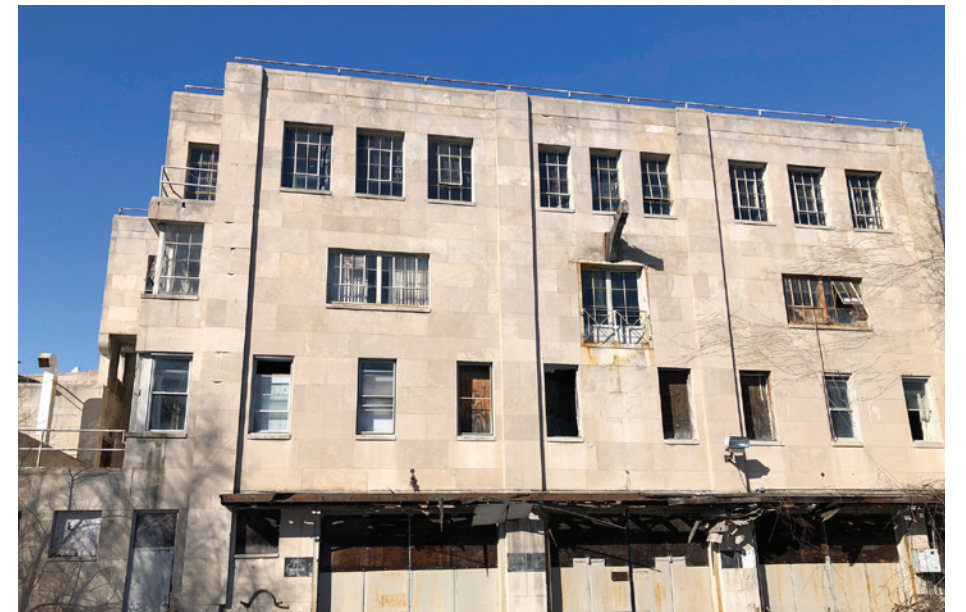
The exterior masonry, windows and doors of the existing South Block building have been compromised in a manner similar to that of the North Block. A number of the window lites are either broken or missing. It appears some of the original windows have been replaced, resulting in an inconsistent visual expression.

As with the North Block, the original limestone panels require cleaning, although some of the panels appear to be in generally good condition. Where feasible the Parade Company intends to salvage and reuse limestone panels from the South Block as cladding accents for the new building addition.

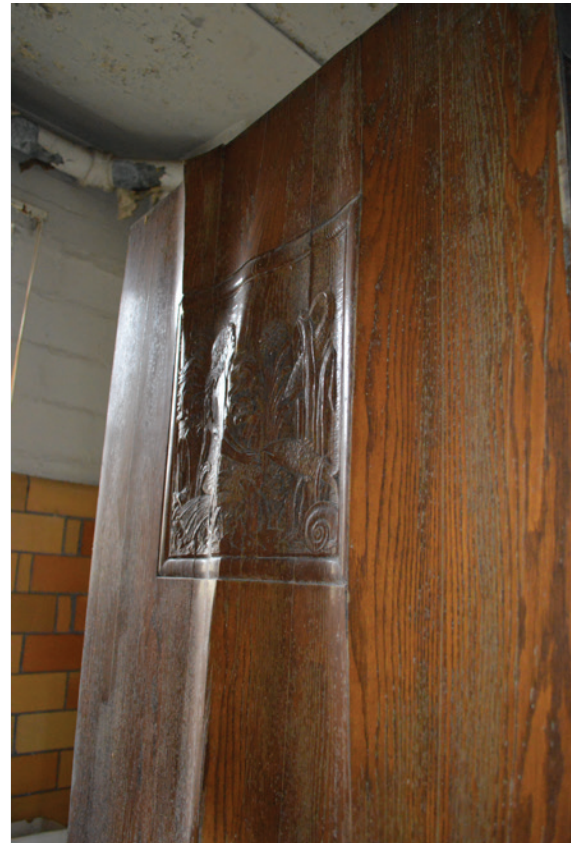
Carved veneer by Tabaczkuk, warped and delaminated

Beginning in the winter of 1991/1992, water from roof leaks severely damaged some of the David Fredenthal murals. Deferred maintenance, vacancy, and vandalism have significantly deteriorated the infrastructure, the finishes, and the artwork of the historic elements.

Water damage is evident throughout the interior and has ruined the original wood parquet floor in the Mail Drill Hall and the historic murals.

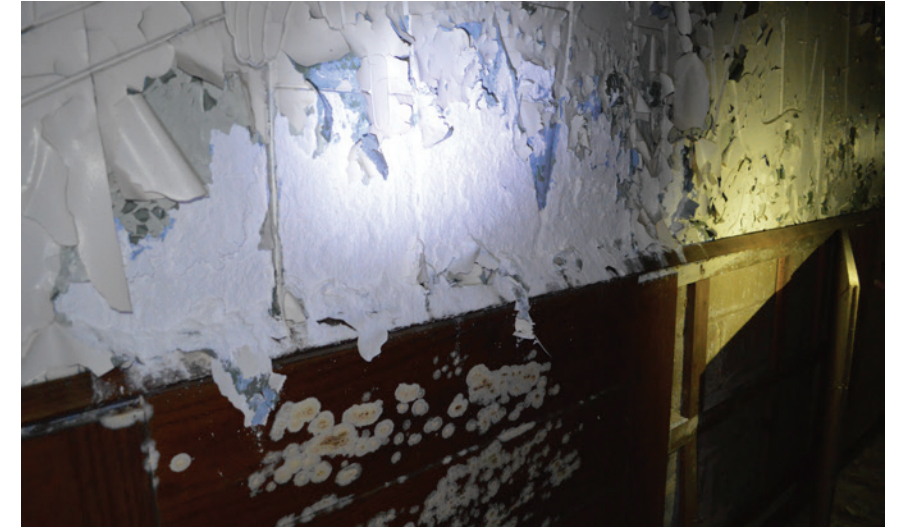
Plaster relief by Gustave Hildebrand, ruined by exposure

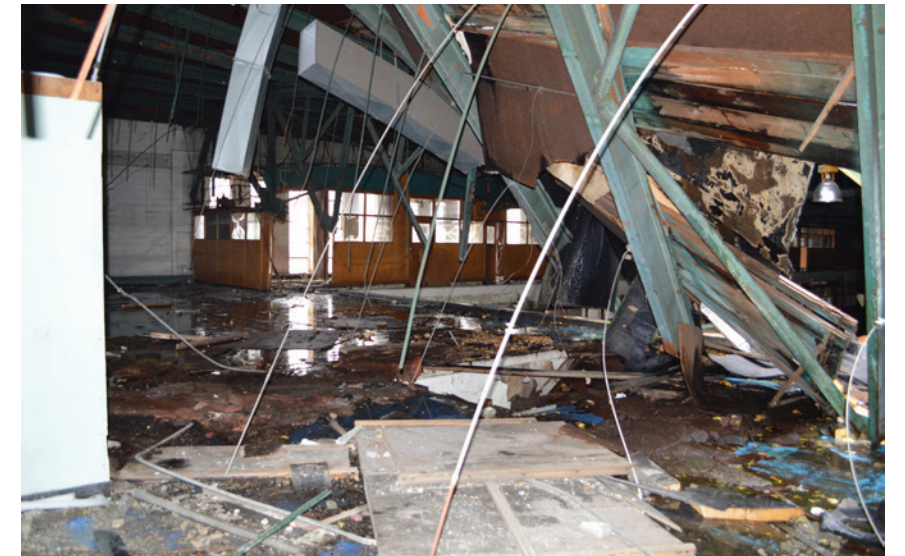
Roof collapse in the Main Drill Hill (Jefferson Avenue Block); scrappers removed bottom chord of roof truss

Scrappers, vandals and graffiti ‘artists’ have added to the rapid and irreversible deterioration of some of the City’s best depression-era treasures. Between 2005 and 2013 scrappers entered the building and removed essential structural members of the southern trusses in the north block. Following a major snow fall in 2014, the weight of the snow caused several of the compromised trusses to fail and the roof collapsed. The structure is a safety hazard.

Existing steel roof trusses appear to be in good condition with the exception of the two south-most trusses which have collapsed and miscellaneous bridging and x-bracing that has been removed.

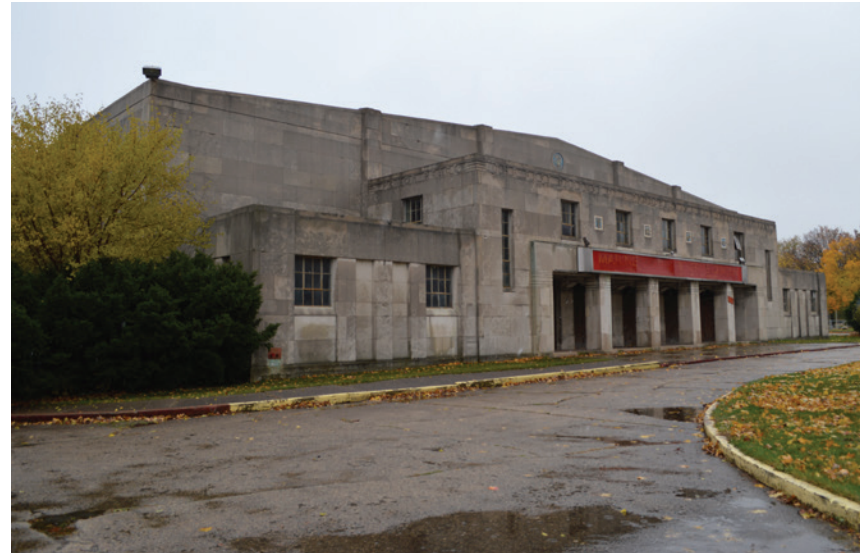
Iconic Jefferson Avenue north facade

- » Iconic Jefferson Avenue facades (north, east, and west)
- » Historic Marker (stone) along sidewalk
- » Front doors, decorative tile work, stonework details, and fenestration on Jefferson façade
- » Entry vestibule and mezzanine along Jefferson
- » Side entrances (west)
- » High bay drill hall (+/- 30,000 square feet) with repairs to roof and exposed trusses

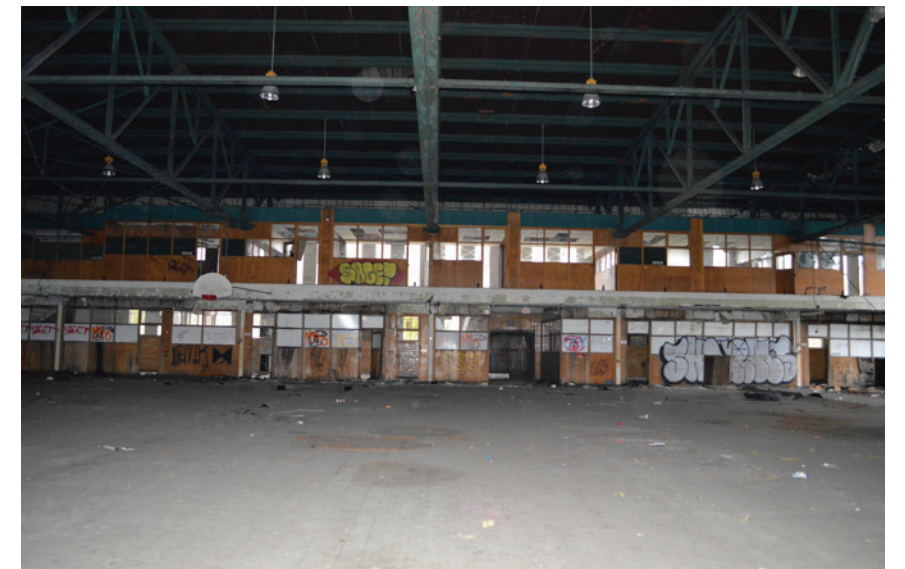
High-bay drill hall with exposed trusses

- Repair/replace steel roof structure.
- Replace roof with energy compliant roof system.
- Clean and repair all coping and parapets.
- Clean and repair all limestone facades.  
Use salvaged limestone from South Building where panels are broken or beyond repair.
- Replace all historic steel windows and mismatched replacement windows with high energy efficient aluminum-framed insulated glass units. Mullions and frame profiles to match aesthetic of historic steel-framed windows.
- Repair or replace all historic exterior doors.

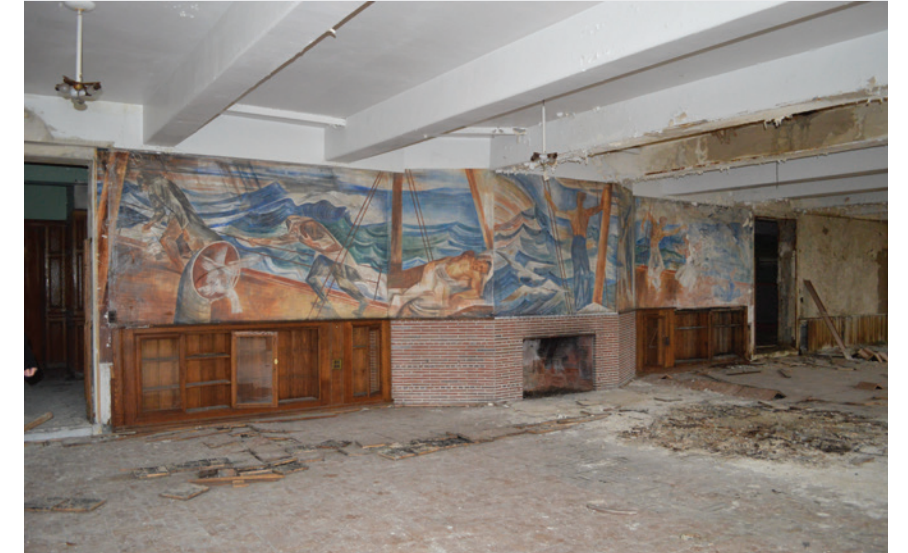
David Fredenthal mural in South Block

The architect and the general contractor for this project are currently investigating procedures for safely removing and relocating historic elements in the South Block. The murals present a unique challenge because the plaster is water damaged and the 1930 vintage concrete block installation used a weak mortar.

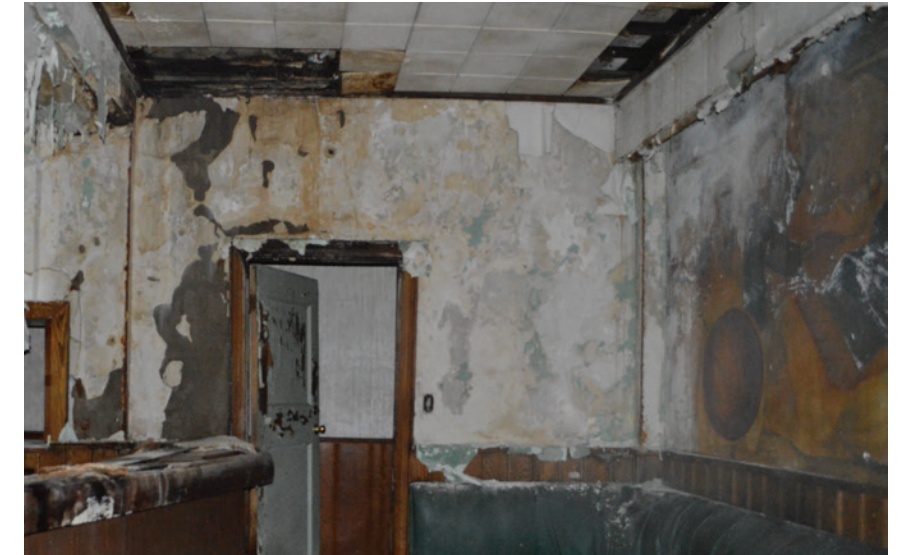
Fredenthal mural and wood door trim in bar area

Weather and time have not been kind to the interior of the woodwork and murals in the South Block. In the four years since the 2015 Due Diligence Report, the continued deterioration is visibly measurable when compared to 2018 photographs. Soon there may be virtually nothing remaining to retain without intervention.

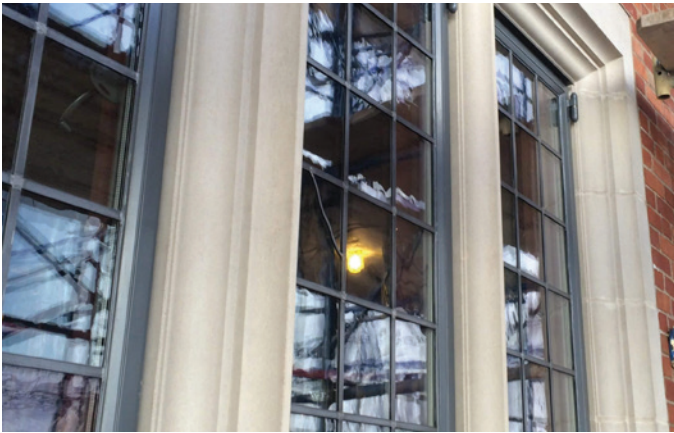
HISTORIC WINDOW REPLACEMENT

ALUMINUM FRAMED GLASS IG UNITS  
CUSTOM PAINT TO MATCH HISTORIC COLOR

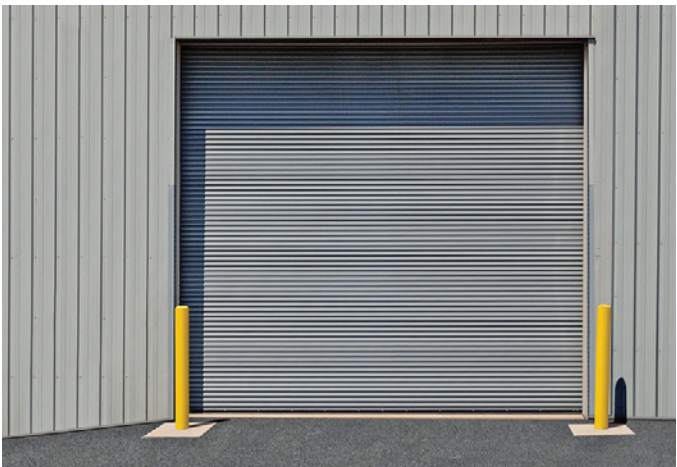
CUSTOM PAINTED STEEL DOORS

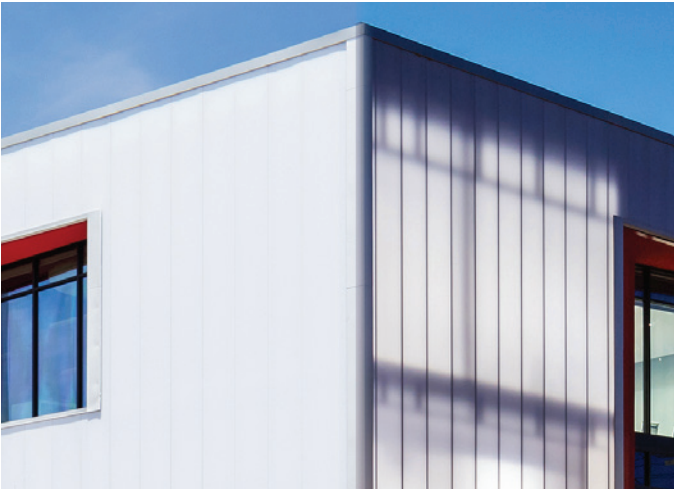
POLYCARBONATE

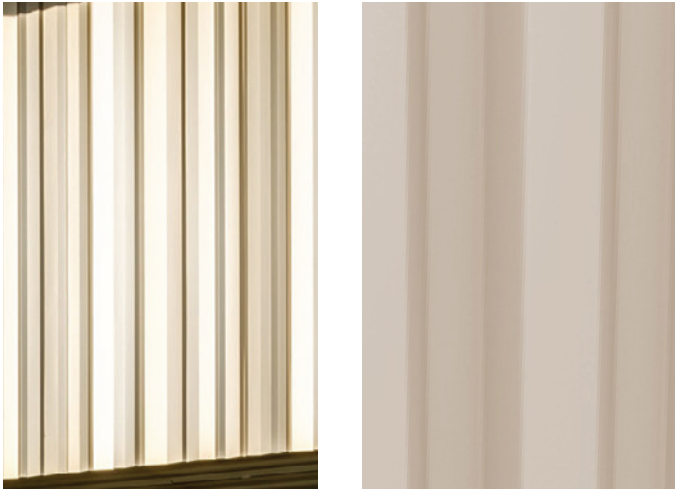
VERTICAL METAL PANEL

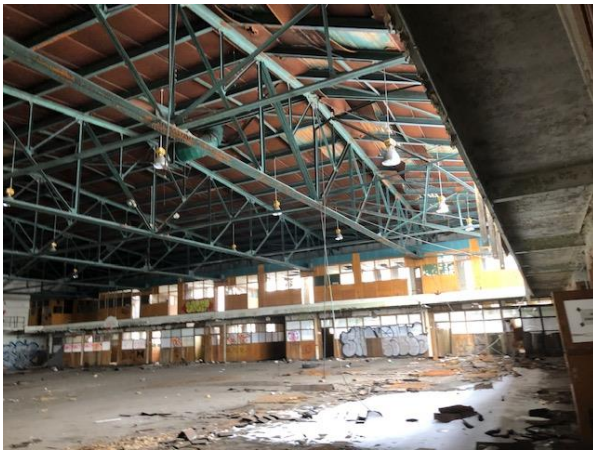
P-1 First-floor structural slab

The first-floor level structural slab was covered by a wood flooring system at the time of the site visit. The wood flooring was uneven and had lifted in many locations throughout. The floor appears to have been exposed to water for some time due to the in-situ condition. It is recommended to permit an allowance in the cost estimate related to the addition of a new leveling surface once the wood flooring is removed. It should be noted that structural restoration of the structural slab may be required after the wood flooring is removed to allow further structural inspection (refer to photograph P-1 and SK-1).

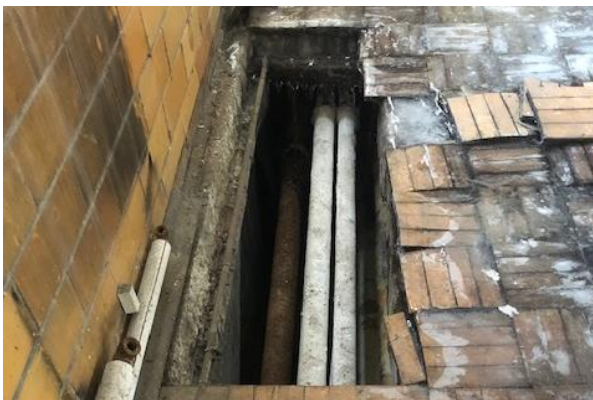
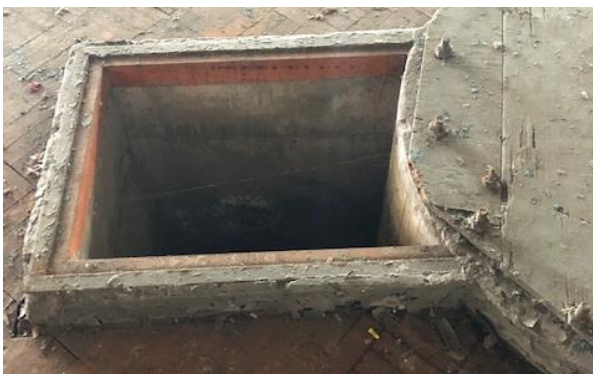
P-2 Mechanical penetrations

There are multiple penetrations through the first-floor structural slab. These penetrations will require infill or encasement to avoid a potential hazardous condition to the future occupants (refer to photographs P-2, P-3, and sketch SK-1).

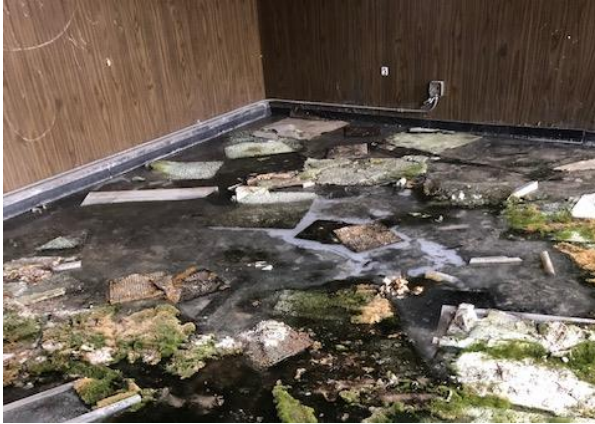
P-4 Mezzanine structural slab water ponding

During the site visit the mezzanine level was accessible with the primary observations made from below the slab due to approximately 2-3" of frozen ponded water covering the floors. The general conditions and issues that need to be addressed are detailed below for each building component:

The mezzanine slab does not present outwardly visible spalling or delamination and is therefore thought to be in generally good condition. However concrete coring is recommended in order to evaluate compressive strength and carbonation.

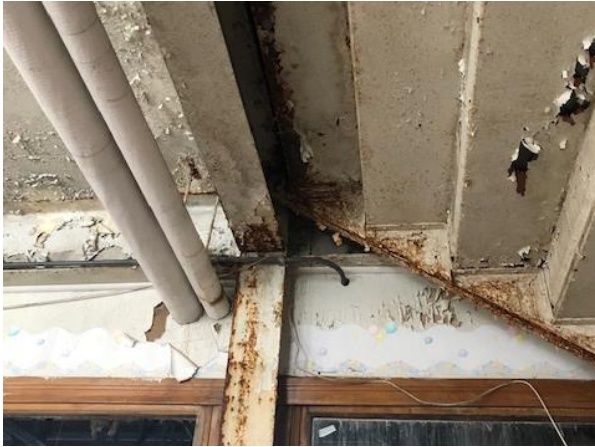
P-7 Corroded stair stringer and connection

The steel stair stringers and their connections are experiencing moderate levels of corrosion (refer to photograph P-7 and sketch SK-2). The members and connections experiencing pack rust type of corrosion are required to be evaluated for section loss prior to being permitted back into service.

Stair stringers and their connections are experiencing moderate corrosion; some must be evaluated for section loss before use.

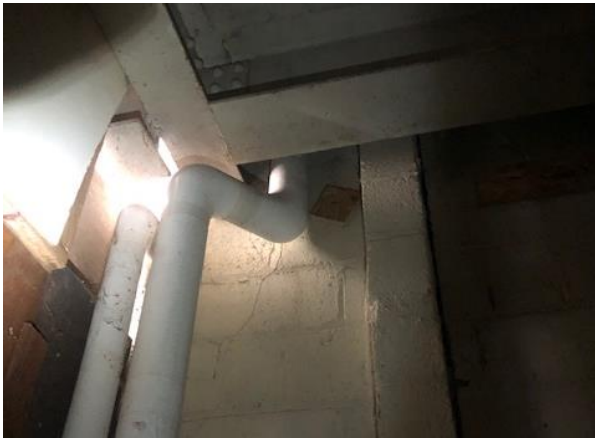
P-8 Masonry wall crack at bearing pocket

The steel beam bearing pockets into the masonry bearing wall are generally in good condition. Minor hairline cracking was observed below (2) beam pocket locations (refer to photograph P-8). While these cracks do not constitute a safety concern at this time, they are recommended to be repaired to maintain the integrity of the construction and prevent additional cracking in the future at these locations.

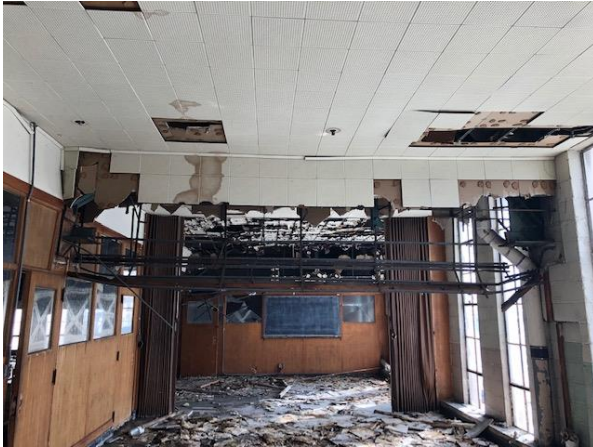
P-10 Removed truss bottom chord (2<sup>nd</sup> truss)

The existing steel roof trusses are in good condition with the exception of the (2) south most trusses which have collapsed and miscellaneous bridging and x-bracing that has been removed. The damage to the end trusses and removed bracing/bridging, is likely the result of a scrapping operation. The (2) south most trusses require removal and replacement due to the amount of damage that occurred during the presumed scrapping operation (refer to photographs P-10, P-11, and sketch SK-3). Bottom chord bridging and x-bracing is required to be reinstalled at the locations indicated on plan sketch SK-3 (refer to photograph P-12).

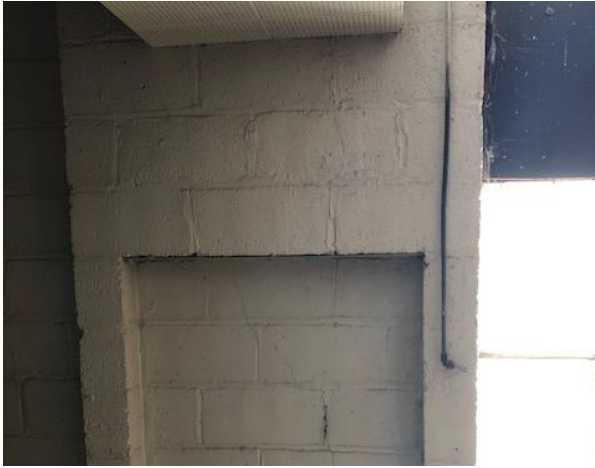
P-16 Hairline cracking at truss bearing pocket

Minor hairline cracking was observed in the masonry piers located at the truss bearing pockets (refer to photograph P-16 and sketch SK-3). The total number of locations is unknown due to cladding materials covering most of the locations. While these cracks do not constitute a safety concern at this time, they are recommended to be repaired to maintain the integrity of the construction and prevent additional cracking in the future at these locations.
